Railroad Investigation Report: RIR-23-09

Grade Crossing Collision Between MS Contracting LLC Dump Truck and Amtrak Passenger Train

Mendon, Missouri
June 27, 2022

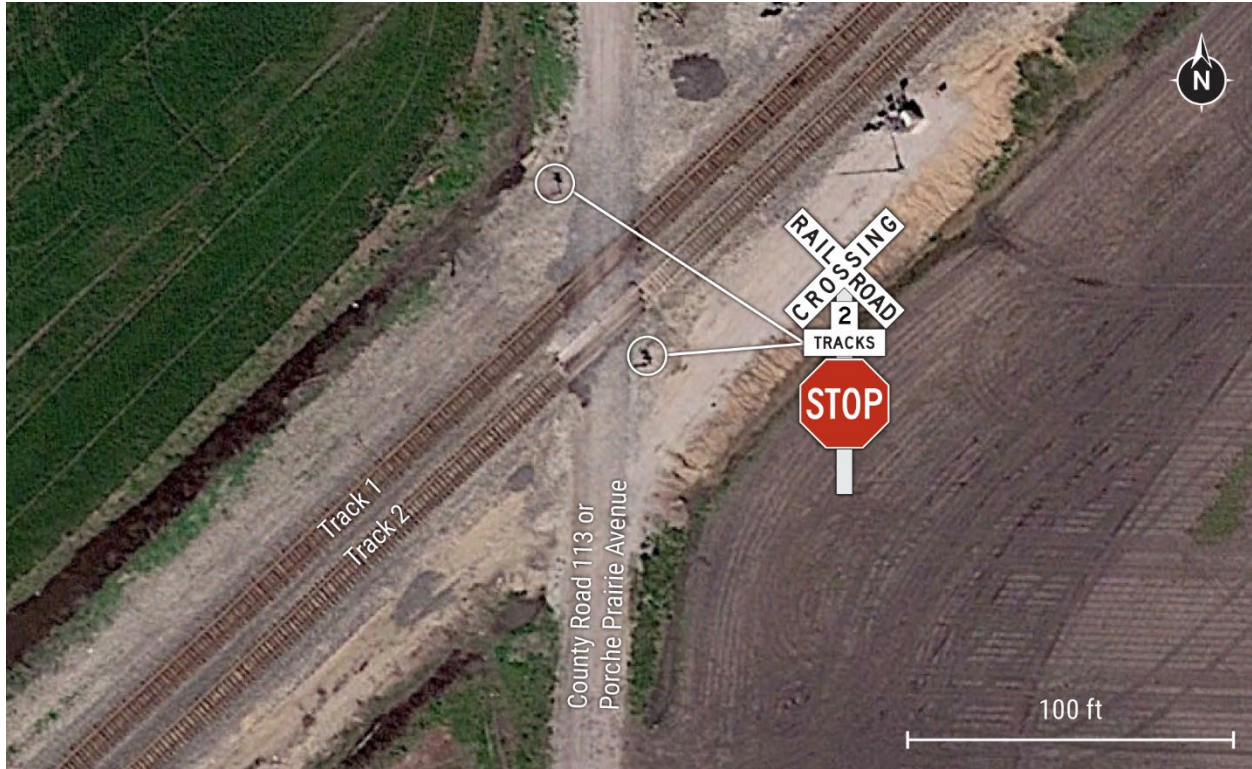
The highway-railroad grade crossing involved in the collision (hereafter the crossing) was number 005284Y in the US Department of Transportation Crossing Inventory.⁴ The crossing was at milepost 363.876 on the Marceline Subdivision where both tracks 1 and 2 (Amtrak train 4 was on track 2) of the rail line intersected County Road 113, a gravel road also known as Porche Prairie Avenue. (See figure 2.) The crossing was a *passive crossing*, meaning that it was not equipped with active warning or barrier systems such as flashing lights or gates.⁵ Instead, it was equipped with crossbucks and stop signs for both north- and southbound highway traffic.

Figure 2. The crossing. (Source: Google Earth.)

The crossing where the collision occurred was a passive skew intersection equipped with crossbucks and stop signs.¹¹ County Road 113 intersected the rail line's two tracks at a 45° angle and ran north to south; the rail line ran northeast to southwest.

After the collision, Chariton County closed the involved crossing. In collaboration with the City of Chillicothe and the Missouri Department of Transportation, Chariton County has developed a plan to close several other passive crossings and redesign local roads to direct traffic through active crossings. Chariton County proposed its plan during a public meeting in April 2023 and is in the process of obtaining state or federal funding to make the planned changes. As of July 2023, the Missouri state budget includes \$50 million for improving grade crossing safety, and the Missouri Department of Transportation plans to use a portion of those funds to address passive grade crossings.

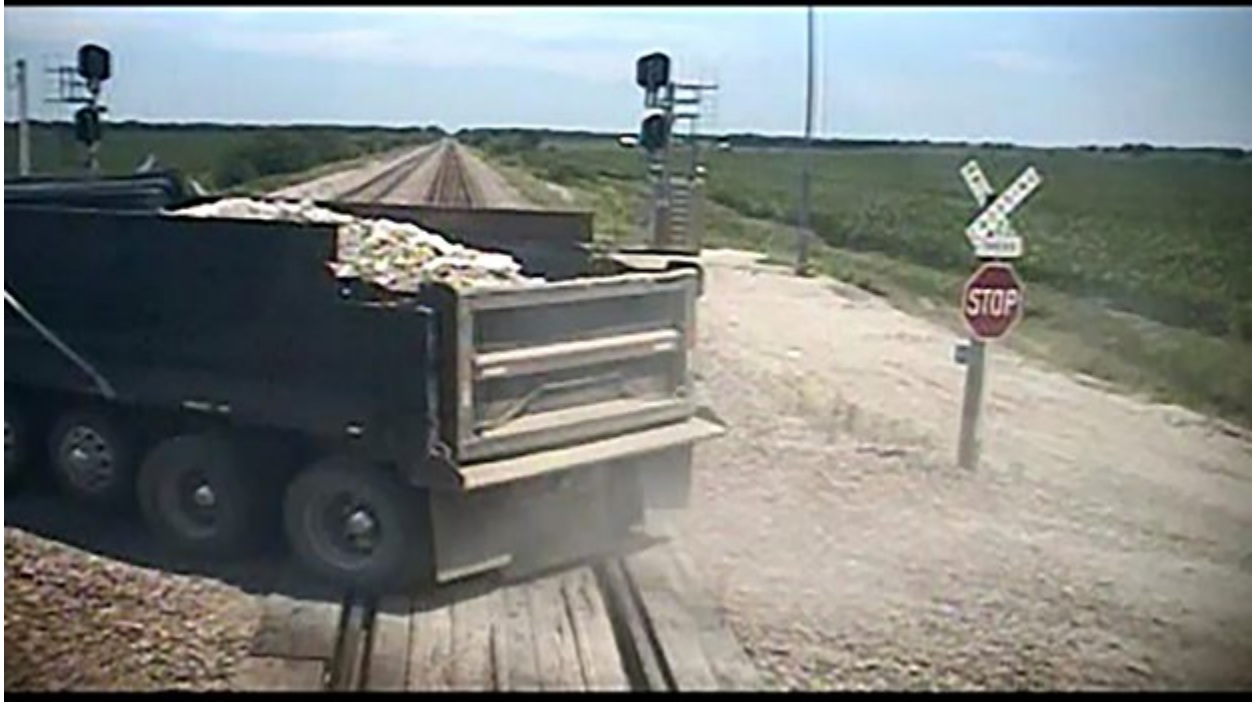
Figure 3. Truck in the crossing shortly before collision. (Source: Amtrak.)

The NTSB's review of forward-facing image recorder data from the lead locomotive showed that the truck proceeded into the crossing without stopping. Missouri state law requires highway traffic to stop between 15 and 50 feet from a highway-railroad grade crossing if the crossing is equipped with a stop sign or if a train is within hazardous proximity—conditions that were both present as the truck neared the crossing before the collision. However, the truck driver maintained a speed of about 5–6 mph through the crossing as shown by image recorder data. The stopped tachometer and speedometer recovered after the collision showed values of about 1,100 rpm and 5 mph, which were consistent with the image recorder data. A driver of a similar dump truck who was familiar with the crossing and saw the collision (the witness driver) characterized this speed and rpm as typical for crossing the tracks. The witness driver also said that he did not usually stop at the crossing as required by Missouri law because the steep grade made starting again difficult. The collision truck driver's movement through the crossing was therefore consistent with how the witness driver would proceed with no train present. This suggests that the driver involved in the collision did not see the train as he approached and entered the crossing.

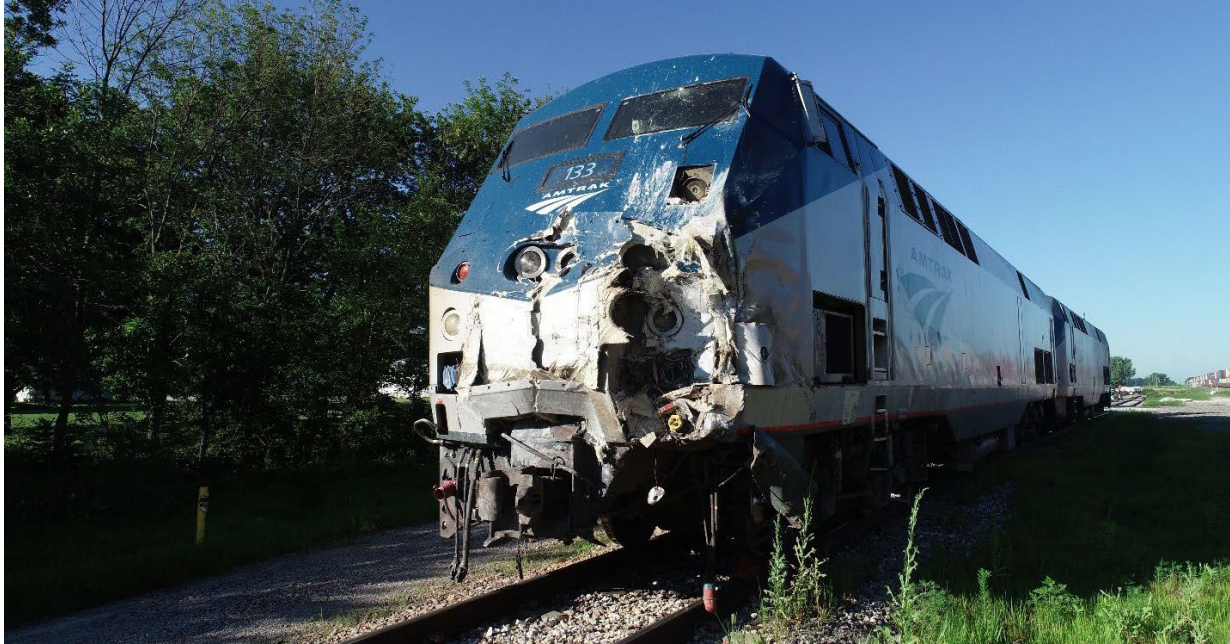
The NTSB performed on-scene examinations of derailed equipment on June 28-29, 2022. The NTSB found collision damage to the lead locomotive's left-front bulkhead. (See figure 4.) Distance measurements showed that the train continued moving east after the collision, and the front of the lead locomotive came to rest 1,286 feet east of the crossing. Both locomotives and all eight railcars derailed; seven railcars overturned and came to rest on their right sides.

Figure 4. Damage to the front-left bulkhead of the lead locomotive.
