# LIMITED INDOOR AIR QUALITY SURVEY

Fire Station #6  
3112 Chapel Hill Road  
Columbia, MO 65203

Nova Project No: Q23-8090  
Inspection Date: October 18, 2023

**Re: Limited Indoor Air Quality Survey  
Fire Station #6  
3112 Chapel Hill Road  
Columbia, MO 65203  
Nova Project No.: Q23-8090**

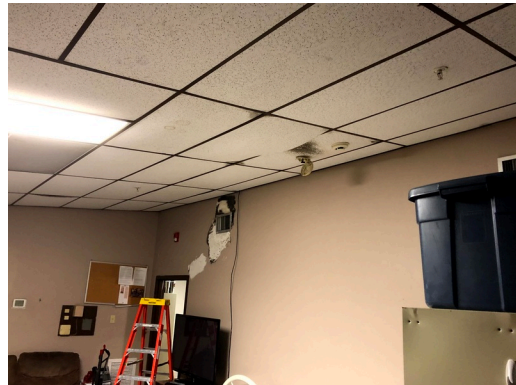
- Approximately thirty-three (33) ceiling panels were observed with water stains and areas of suspect fungal growth throughout the building interior.
- Plaster wall cracks and damage were observed in the dormitory (bedroom) along the north wall.
- A small area of suspect fungal growth was observed on the drywall ceiling around the shower light. The nearby fire sprinkler head (ceiling) was observed with rust staining.
- Staining of carpet was observed.
- Standing water was observed by the washing machine (Apparatus Bay)

10. Stained Ceiling Panels and Damaged Plaster (Bedroom)

- Interior water impacted and damaged building materials should be further evaluated to determine the source and extent of water intrusion. Damaged materials that cannot be cleaned should be removed and replaced.

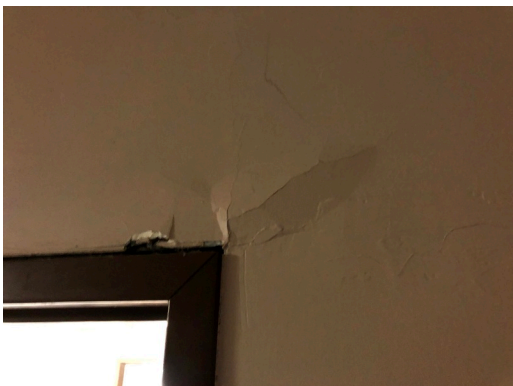
11. Damaged Plaster

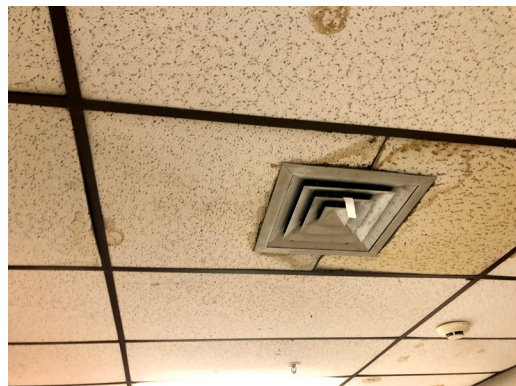
The water staining on the ceiling panels appeared in random locations with no obvious source of origination (i.e., roof, piping, rust). Nova believes that the staining is related to condensation of HVAC ductwork and observed residue.

12. Stained Ceiling Panels (Locker Room)

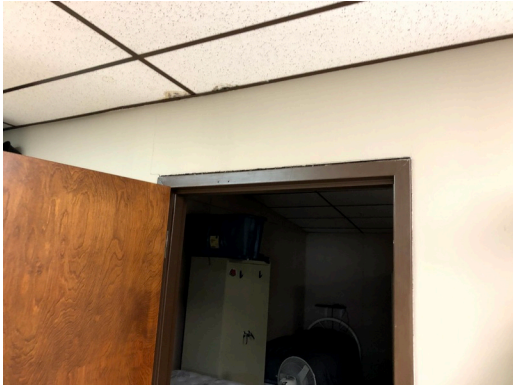
13. Stained Ceiling Panels (Kitchen)

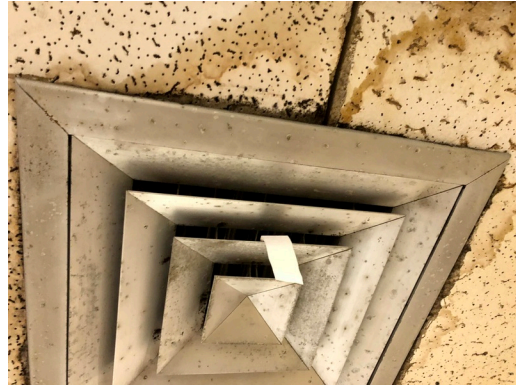
14. Stained Ceiling Panel and Diffuser

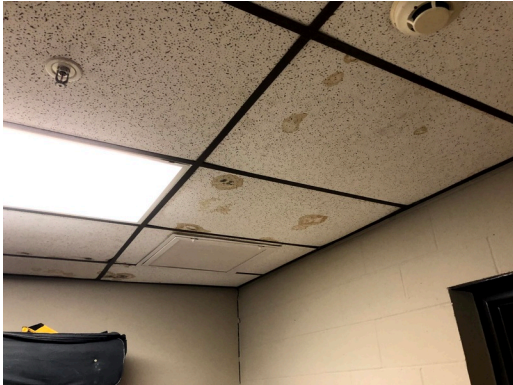
15. Stained Ceiling Panels (Locker Room)

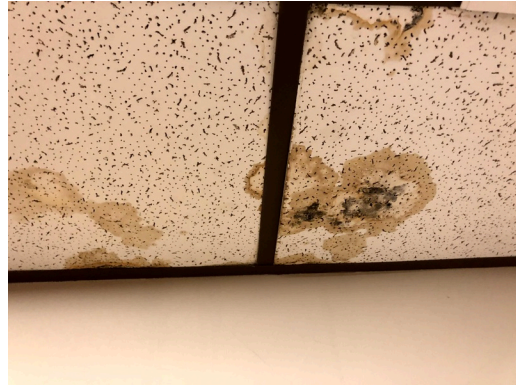
16. Stained Ceiling Panel (Locker Room)

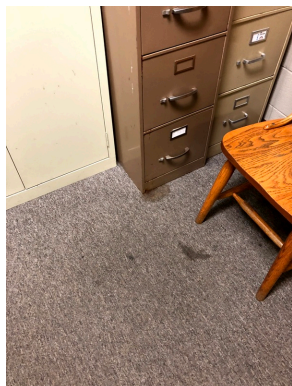
17. Stained File Cabinet and Carpet (Locker Room)

- Additional housekeeping/cleaning and carpet cleaning is recommended.
- Investigate exterior sealants and repair as necessary.
- Investigate roof gutter drainage and associated landscaping to ensure appropriate drainage away from building.

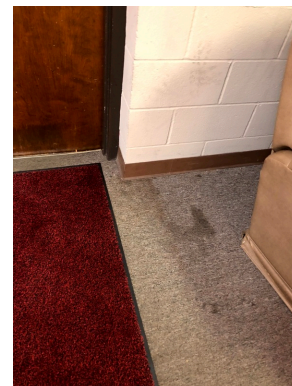
18. Stained Carpet (Locker Room)

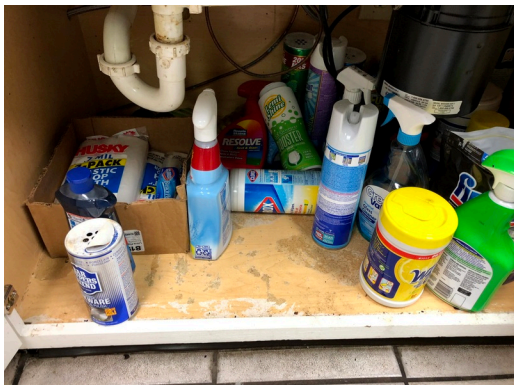
19. Previous Moisture Damage (beneath Kitchen sink)

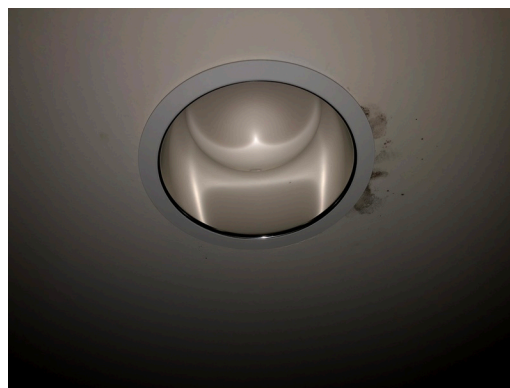
- Several stained ceiling panels/tiles (with suspect fungal growth) were observed within the building interior, including the drywall around the shower light fixture.

22. Stained Drywall above Shower

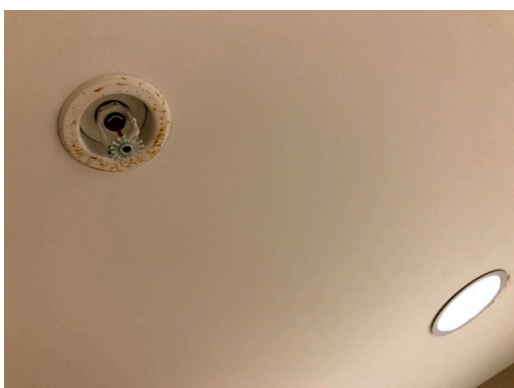
23. Fire Sprinkler rust in Shower area

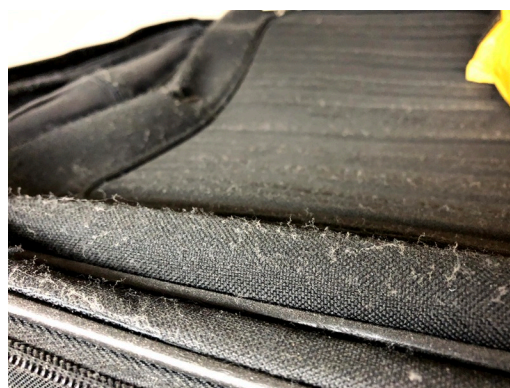
General poor housekeeping and the presence of dust accumulation observed on window ledges, HVAC louvers, personal items, equipment (humidifier/fan) was observed.

24. Dust accumulation on Bag/Luggage

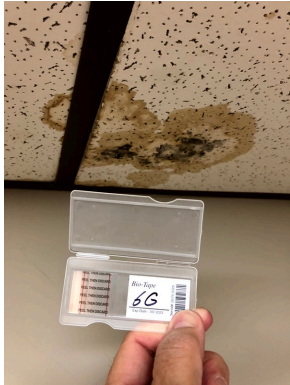
- ▶ Surface sample results:
  - ▶ Sample 6G – Locker Area (ceiling tile): reported “trace” amounts of background debris with Mold Growth Rating (MGR) of 4 (*Ulocladium* - common habitat soil, grasses, wood, paper - water indicator), 4 (Fungal mycelial fragments - connectivity with mold spores) and 3 (*Alternaria* - common habitat soil, seeds, plants, carpet, textiles, window frames, air - found predominantly outdoors).

25. Stained Ceiling Panel - Location of Surface Sample 6G (Locker Area)

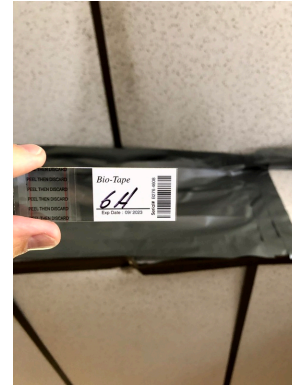
- Sample 6H – Main Entry (ceiling tile): reported “trace” amounts of background debris with MGR of 4 (*Cladosporium* - common habitat plants, food, soil, paint, textiles, carpet, HVAC, air - found indoors and outdoors), 3 (*Aspergillus/Penicillium* (common habitat being soil, food, carpet, HVAC, air) commonly found in both indoor and outdoor environments. ) and 3 (Fungal mycelial fragments - refer to above)

26. Stained Ceiling Panel - Location of Surface Sample 6H (Living Room)

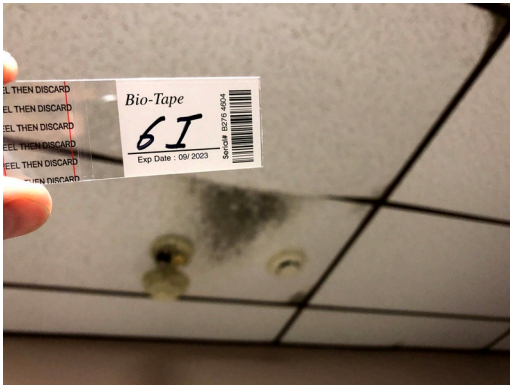
27. Stained Ceiling Panel - Location of Surface Sample 6I (Dormitory)

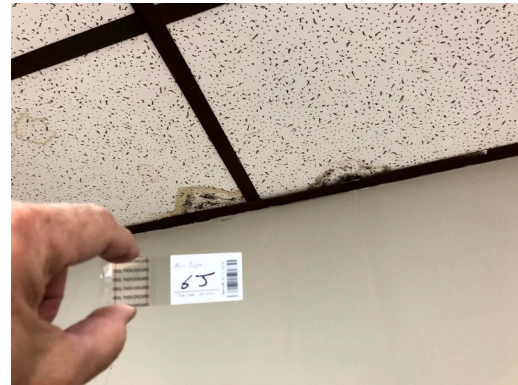
28. Stained Ceiling Panel - Location of Surface Sample 6J (Kitchen)

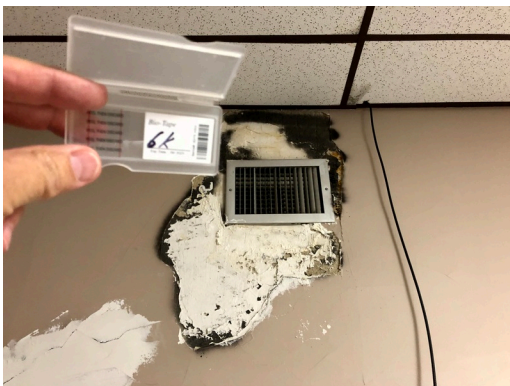
- Sample 6K – Bedroom (damaged plaster area): reported “moderate” amounts of background debris with MGR of 0 (No Fungi Detected)

29. Damaged Plaster - Location of Surface Sample 6K (Dormitory)

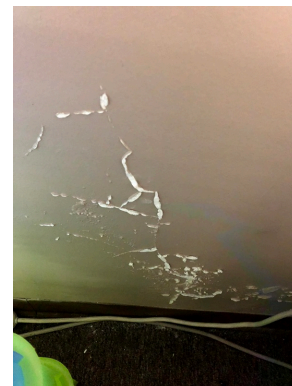
30. Damaged Plaster Area (Dormitory)

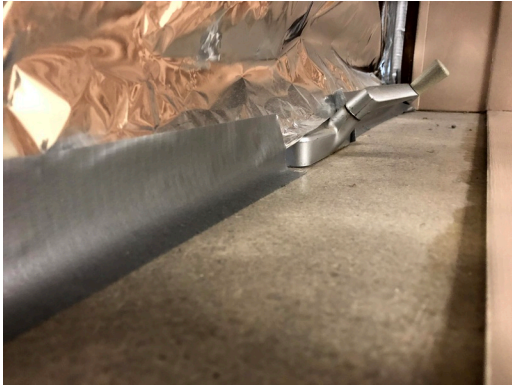
31. Dirt accumulation on Window Ledge

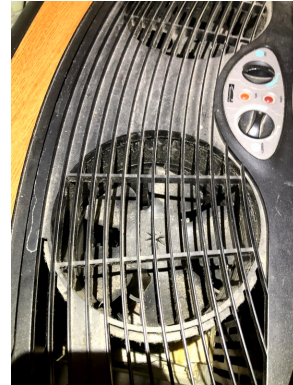
32. Dirt accumulation on Humidifier (Dormitory)

- Maintain temperatures within ASHRAE recommended levels (meaning, maintain the bedroom temperature similar to other areas within the building to avoid condensation)
- Although not in use during Nova’s site visit, minimize the usage of the humidification machine within the bedroom during warm weather

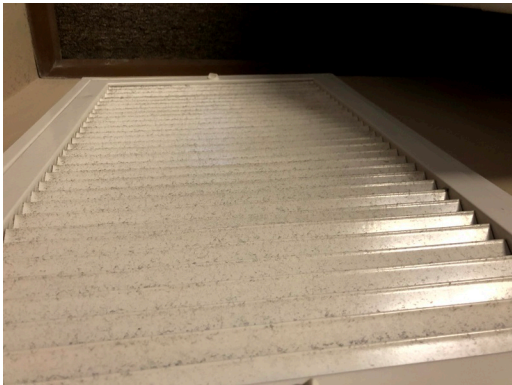
33. Dirt accumulation on HVAC Louver

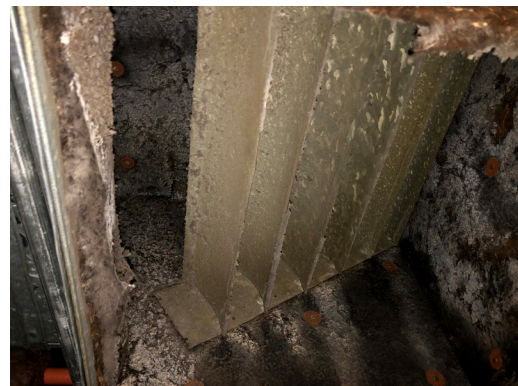
The interior return ductwork was lined with insulation and observed with dust accumulation.

36. Interior duct insulation and dirt accumulation

- Installation of duct insulation in efforts to minimize condensation
- After removal/replacement of water impacted materials and the installation of insulation, interior duct cleaning and HVAC filter(s) replacement is recommended, and

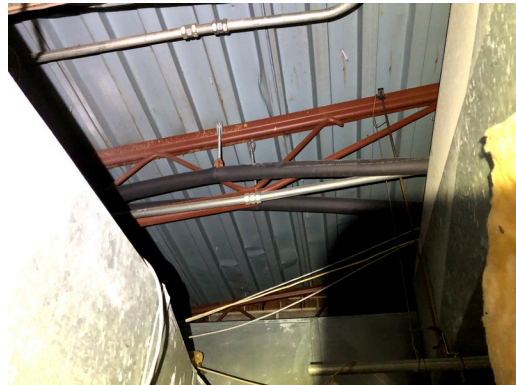
39. View above Ceiling Panel at Metal Roof Decking

Water evaporation stains/residue was noted on the supply ductwork located above the ceiling panels.

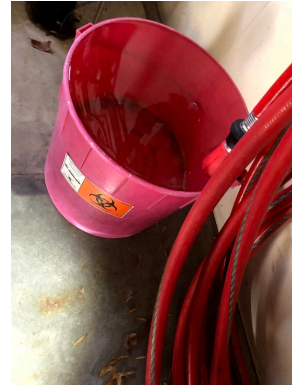
- Standing water in a bucket (labelled with a bio-hazard sticker) was observed in the Apparatus Bay
- Standing water was observed near the washing/laundry equipment

44. Full Bucket of Liquid with Hose (Bucket labelled as BioHazard)

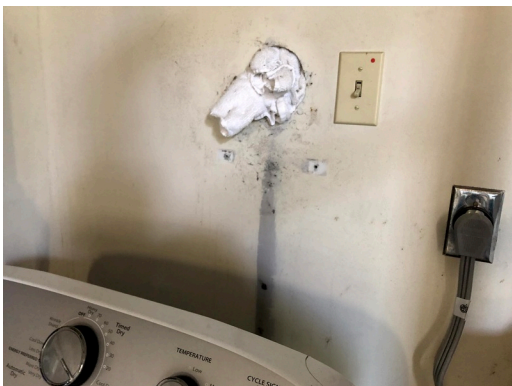
- Exterior - Open hole was observed in former dryer vent perimeter wall penetration
- Exterior - evidence of poor drainage, elevated landscaping (above concrete foundation), exterior rust on metal door threshold, and concrete settlement was observed

47. Former Dryer Vent Exhaust

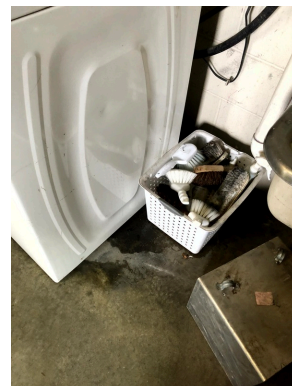
48. Water Accumulation and Staining in Apparatus Bay

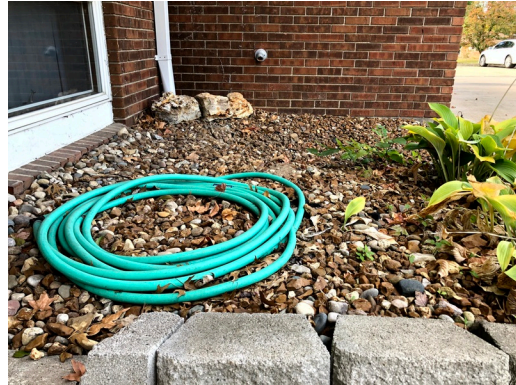
50. Poor drainage and landscaping

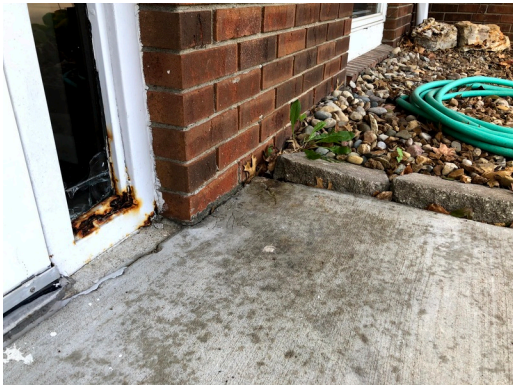
51. Threshold rust and elevated landscaping

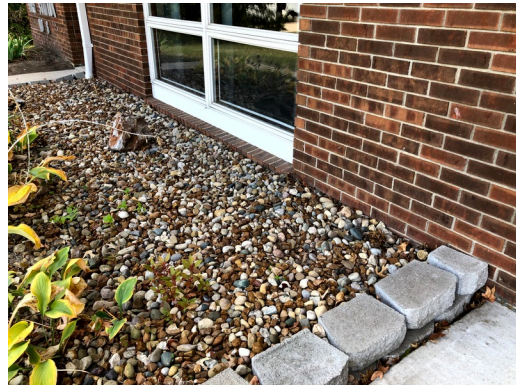
52. Elevated landscaping

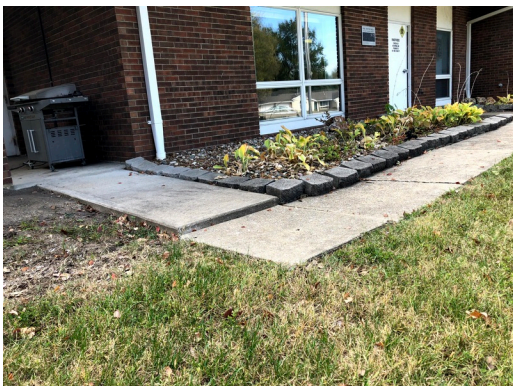
53. Concrete settlement

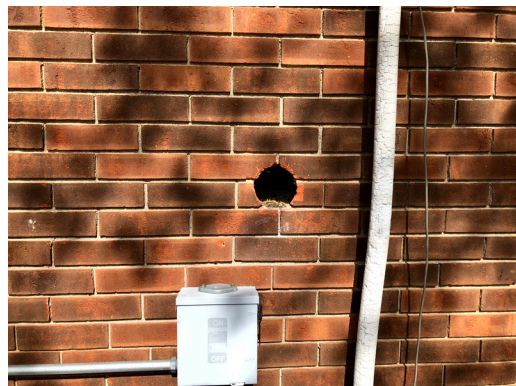
54. Location of former dryer vent
