UNIVERSITY OF MISSOURI DAMAGE REPORT

3. DATE DAMAGE OCCURRED 10/24/2023	4. BUILDING OR FACILITY IN WHICH DAMAGE OCCURRED (include room No. or otherwise describe exact location) South Residential Hall

8. DESCRIBE CAUSE OF HOW DAMAGE OCCURRED City of Columbia Water line (16") Break adjacent to the property.			
9. STATE WHAT THE DEPARTMENT HAS DONE, OR WHAT IT WILL DO IN THE IMMEDIATE FUTURE TO HELP PREVENT SIMILAR DAMAGE N/A

RE: CP240098- Southwest Campus Housing- Water Damage Repairs

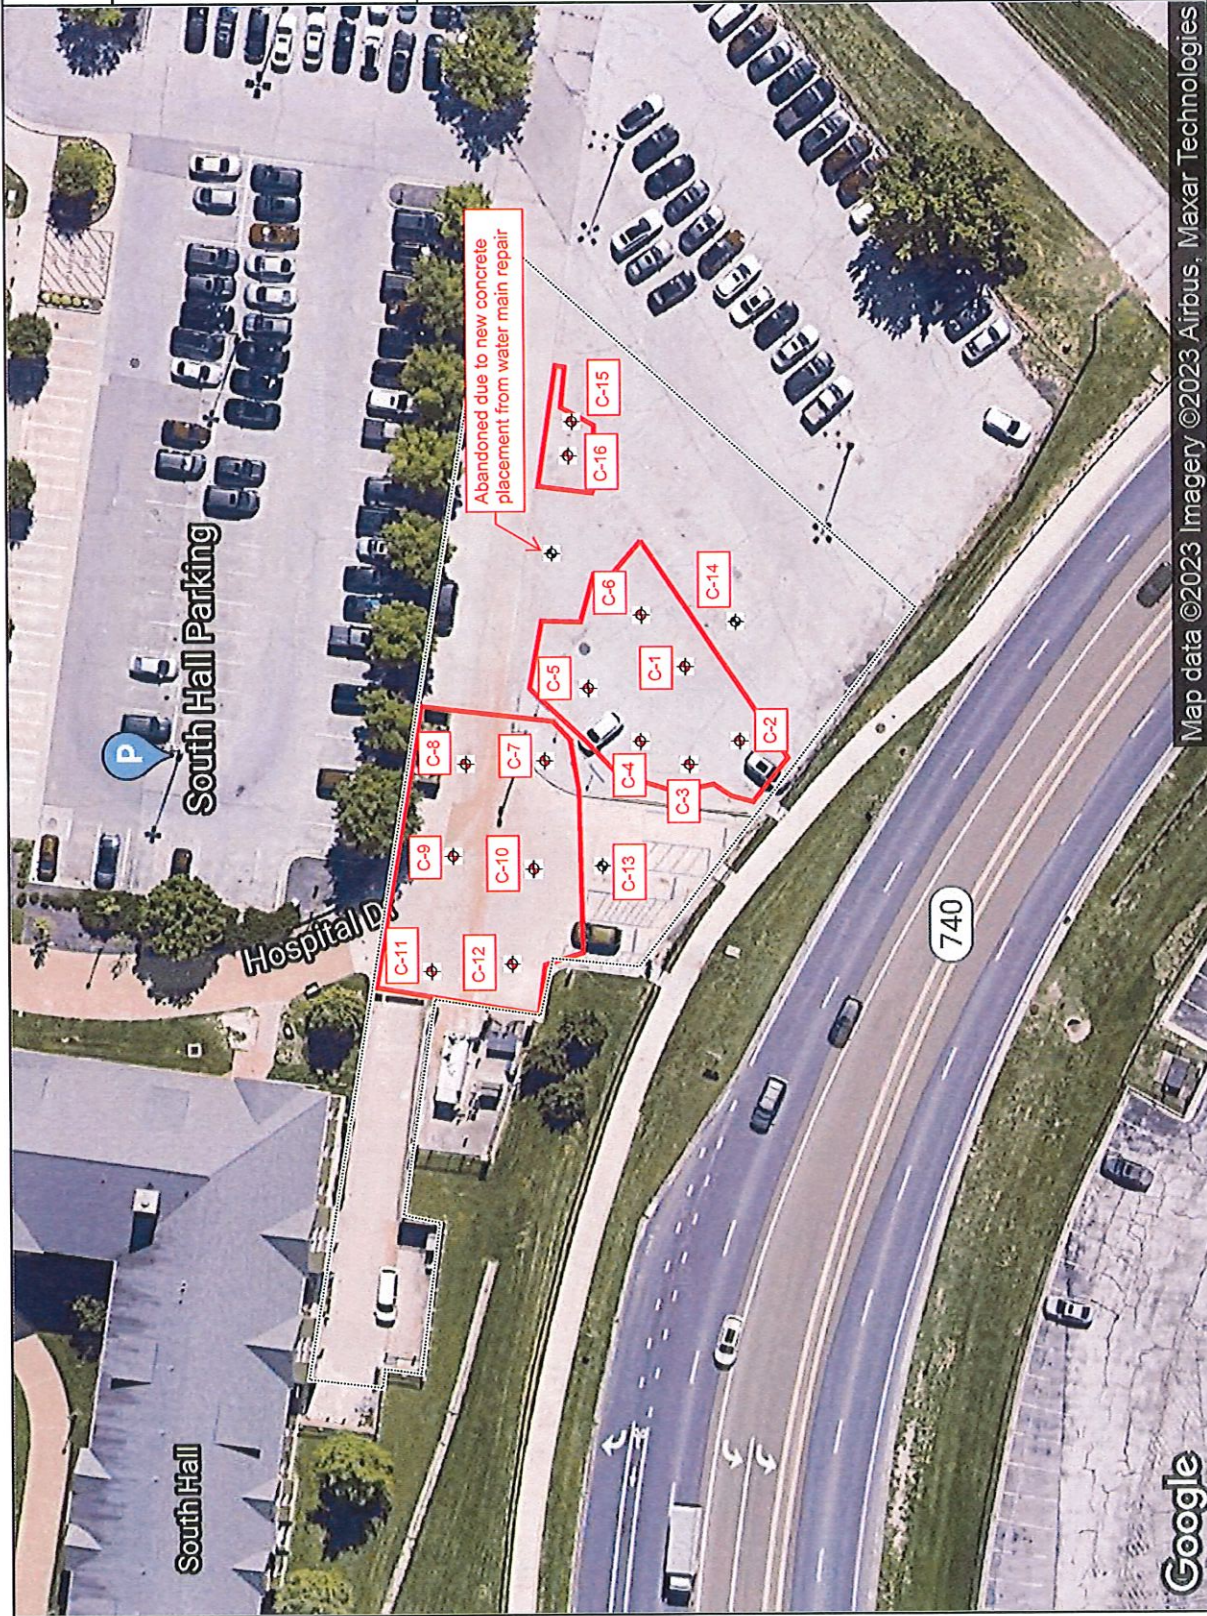
GPRS FINDINGS MAP

Core Holes C-13 and C-14 were obtained outside of the designated areas to verify the boundaries of the GPRS scan. No voids were observed at these core locations.

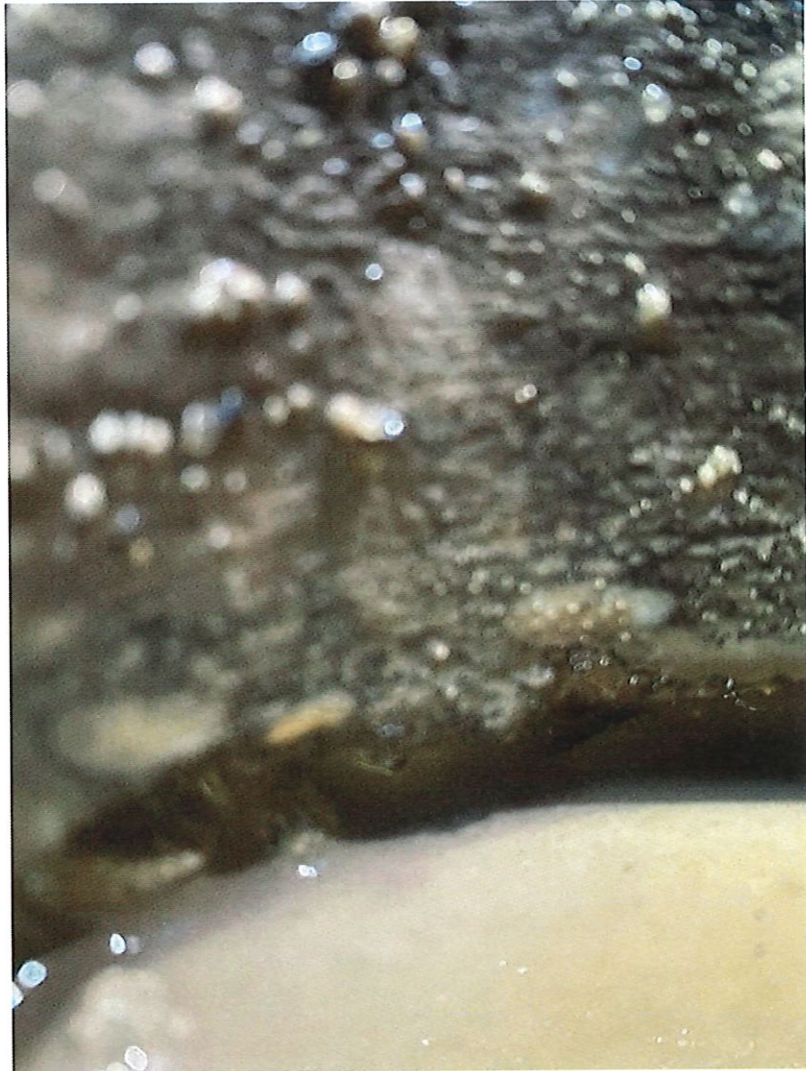
Core Hole C-6

Photo of void was difficult due to steady water flow into the core hole.

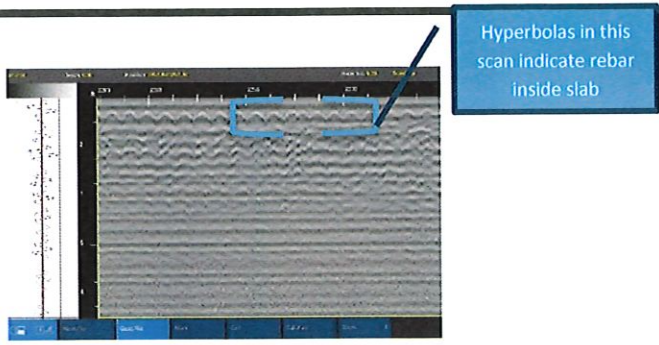
Picture 1: Utility Cart scan on concrete from south to north.
No evidence of void in this data.

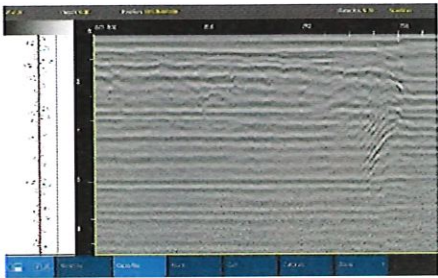
Picture 3: Utility Cart scan on paved area from north to south.
No evidence of void in this data.

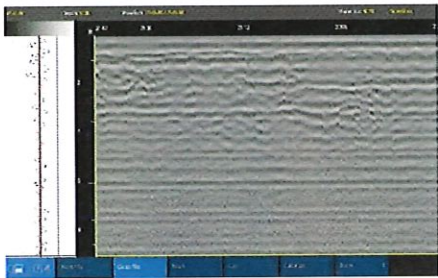
Picture 5: Utility Cart scanned on both pavement and concrete from east to west. No evidence of void in this data.

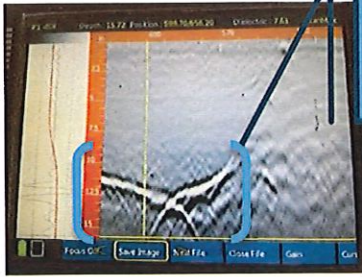
Sudden bright "black, white, black" reaction from air gap indicating potential void

Picture 7: The above data screenshot shows a potential void found in Area A. This data screenshot shows a high amplitude negative response in the data that is consistent with those of a void.

After conducting scans with concrete antenna and utility cart findings would indicate potential voids throughout large portions of area marked out by client. When visually inspecting areas where bottom of slab is visible (i.e. cracks in pavement and edge of concrete near storm drain) 1"-2" gaps can be seen between slab/asphalt and ground. Client is advised to pilot hole areas in slab and pavement to confirm existence of voids.

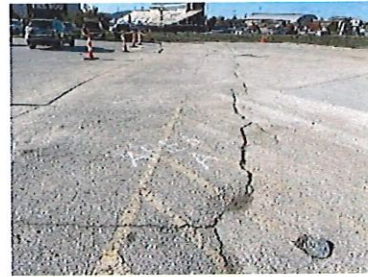
Picture 8: The above photo was taken facing west. This area contained a potential void that was shown in picture 7.

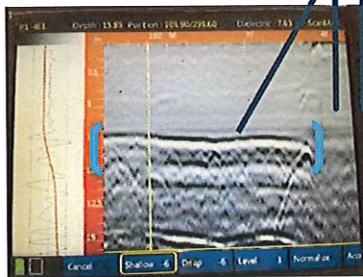
Sudden change in data at bottom of pavement could indicate area of void due to washout/erosion

Picture 9: The above data screenshot shows a potential void found in Area B. This data screenshot shows a high amplitude negative response in the data that is consistent with those of a void.

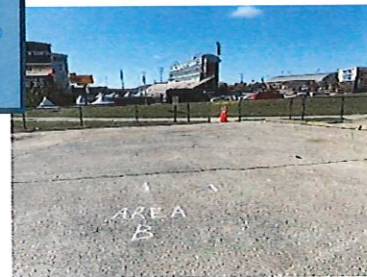
Picture 10: The above photo was taken facing west. This area contained a potential void that was shown in picture 9.

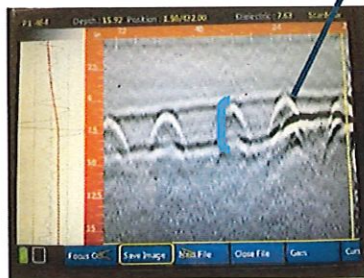
Abrupt change in brightness and depth indicates potential void

Picture 11: The above data screenshot shows a potential void found in Area C. This data screenshot shows a high amplitude negative response in the data that is consistent with those of a void.

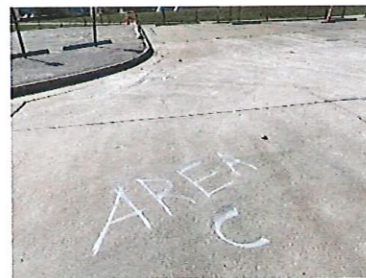
Picture 12: The above photo was taken facing west. This area contained a potential void that was shown in picture 11.
