UNIVERSITY OF MISSOURI DAMAGE REPORT

3. DATE DAMAGE OCCURRED 10/24/2023	4. BUILDING OR FACILITY IN WHICH DAMAGE OCCURRED (include room No. or otherwise describe exact location) South Residential Hall

8. DESCRIBE CAUSE OF HOW DAMAGE OCCURRED City of Columbia Water line (16") Break adjacent to the property.			
9. STATE WHAT THE DEPARTMENT HAS DONE, OR WHAT IT WILL DO IN THE IMMEDIATE FUTURE TO HELP PREVENT SIMILAR DAMAGE N/A

RE: CP240098- Southwest Campus Housing- Water Damage Repairs

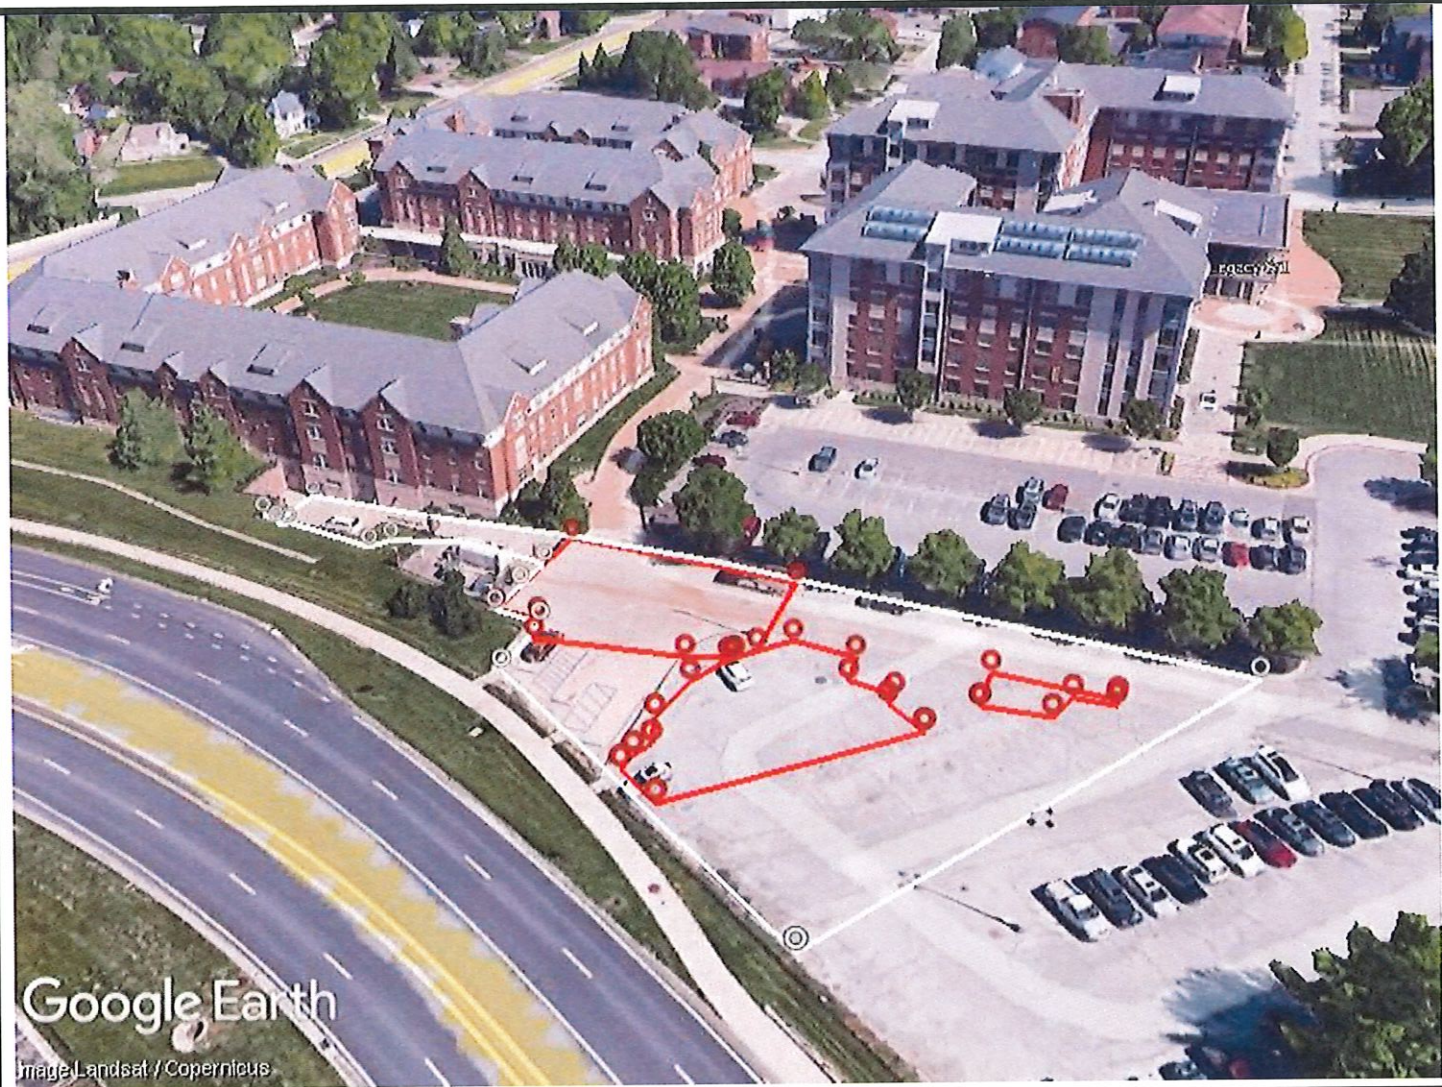
Based on the areas scanned, potential voids were found within the areas shown in the supporting photos, data, and site map provided. The following pages outline data from scans performed during this investigation. Some potential utilities were located during the scan process. However, these were outside the scope of this particular project. The following pages will provide further explanation of the findings.
